# **EXHIBIT H**

## Degradation of polypropylene *in vivo*: A microscopic analysis of meshes explanted from patients

#### Vladimir V. lakovlev, 1 Scott A. Guelcher, 2 Robert Bendavid 3

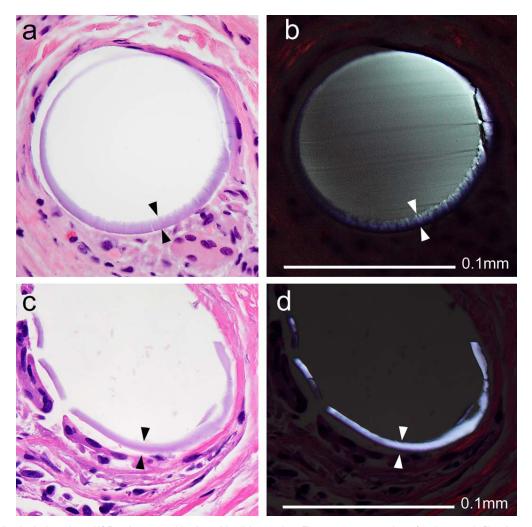
FIGURE 2. Histological sections, H&E stain, ×100 objective with oil immersion. The same cross section of a clear mesh fiber in regular (a) and polarized (b) light. The fiber has a layer of staining degraded polypropylene at the surface (between arrowheads). This layer has refractile properties of polypropylene in polarized light (b). In some areas the non-degraded core of the fibers detaches during histological processing while segments of the degraded layer stay attached to the tissue. Separated degradation layer in regular (c) and polarized (d) light. At sites like this, intensity of light passing through the degraded layer cannot be attributed to light scatter from the core. Note that tissue components including collagen have a much weaker birefringence than polypropylene (b and d). [Color figure can be viewed in the online issue, which is available at wileyonlinelibrary.com.]

polypropylene. In polarized light, both the central core of the fibers and the outer layer showed similar refractile properties [Figure 2(b)]. The light intensity was uniform within the core while the outer layer had gradual reduction of the refractile ability toward the surface. Birefringence of the outer layer was also observed in the segments of the "bark" separated from the core [Figure 2(c,d)]. At these sites, the light brightness in the "bark" layer was due to its internal properties and could not be attributed to the scatter of light from the core. The adjacent tissue components containing collagen also showed birefringence, however of a much lower intensity. The tissue components also had a different structure and coloration

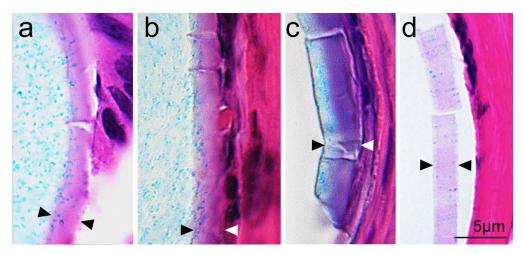
FIGURE 3. Degradation "bark" of the blue fibers manufactured with inclusion of blue dye granules, H&E stain, ×100 objective with oil immersion: (a) and (b) non-degraded core (left half of the images) and the degraded layer (between arrowheads). Note that the blue granules are retained in the layer of degraded polypropylene. Within the degraded "bark," the granules degrade and loose color toward the surface. In (c) and (d) the non-degraded core detached from the slides similarly to Figure 2(c,d). At these sites, presence of the granules in the separated "bark" cannot be attributed to an overlap with the core. [Color figure can be viewed in the online issue, which is available at wileyonlinelibrary. com.]

into the material during its manufacture (Figure 3). The granules were seen in the non-degraded core of the fibers as well as to a variable degree in the outer degradation layer. In the latter, they were detected within the "bark" remaining on the core [Figure 3(a,b)] as well as in the segments of the "bark" separated from the core [Figure 3(c,d)]. The granules were mainly seen in the deeper layers of the "bark" and were not as frequent closer to the surface, which suggests that they also undergo degradation and lose color. The finding was a direct confirmation that the "bark" originated from the same material as the core of the fibers.

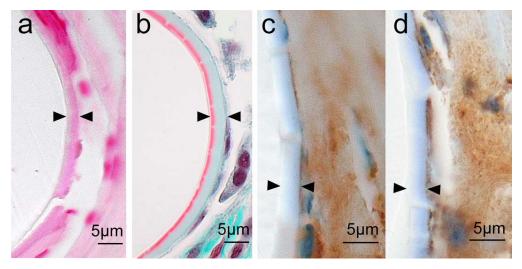
The brittleness, staining and birefringence characteristics of the "bark" were similar to those of calcium salts which are commonly deposited in degenerating tissues. Von Kossa stain was used for a sample set of 10 specimens to rule out presence of calcium salts in the outer "bark." No calcium salts were detected in the brittle outer layer of the 10 specimens tested [Figure 4(a)].

FIGURE 4. Additional stains, all images taken with 100x oil immersion objective and cropped to a different magnification, polypropylene degradation layer is pointed between arrowheads: (a) Von Kossa stain is negative for calcium in the brittle "bark" (would stain calcium black), (b) trichrome stain shows that the deeper parts of the "bark" have smaller staining porosity (red) than those close to the surface (green) which correlates with TEM findings [Figure 6(b)], (c) immunohistochemical stain for immunoglobulin G (lgG, stained brown). IgG is present in almost all human tissues and fluids. It is deposited on the surface of degraded polypropylene but is not mixed within it. (d) Immunostain for the oxidizing enzyme of inflammatory cells myeloperoxidase (stains brown). [Color figure can be viewed in the online issue, which is available at wileyonlinelibrary.com.]

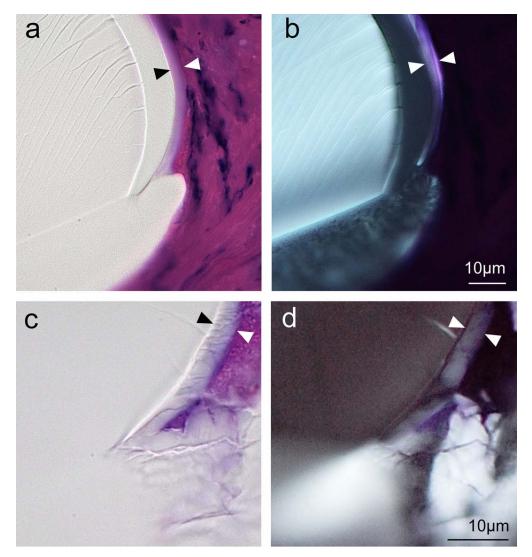
FIGURE 5. Melting of both non-degraded and degraded polypropylene caused by the surgical cautery, H&E, ×100 oil immersion: (a) and (b) the same site of fiber melting in regular and polarized light, (c) and (d) another site showing melding point. While molten the non-degraded core and the degradation "bark" formed a common pool of material. [Color figure can be viewed in the online issue, which is available at wileyonlinelibrary.com.]

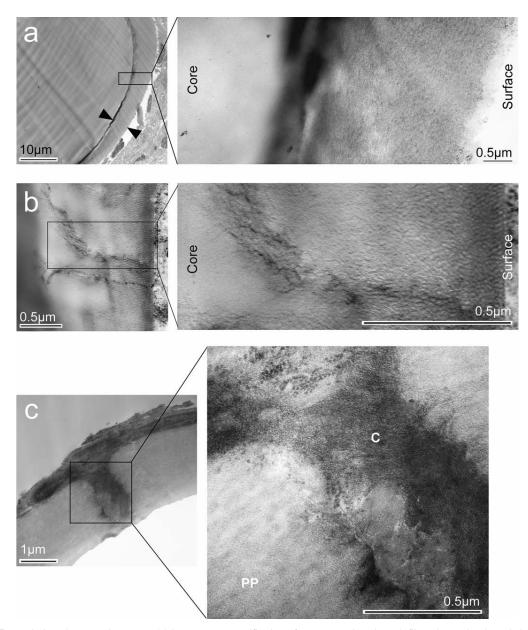
We used TEM to study the ultrastructural organisation of the degraded layer in cross sections. The mesh fibers showed an outer "bark" similar to that seen by light microscopy [Figure 6(a)]. There were no fibrillary (collagen, amyloid etc.) or other structures of connective tissue matrix within the "bark". Material composition of the outer layer and the core showed similar electron density; however, at high magnification the outer "bark" was noticeably more granular, especially toward the surface [Figure 6(a), insert].

The "bark" material had a lattice of fine branching cracks (nanocracks). This network of nanocracks was sparse closer to the core and expanded toward the surface [Figure 6(b)]. As seen in Figure 6(b) in addition to the nanocracks there were also occasional larger cracks occurring at random. These larger cracks seen by TEM corresponded to the cracks seen by light microscopy either on the surface (Figure 1) or in cross sections (Figure 2).

The "bark" either had a gradual transition into the core [Figure 6(b)] or showed a zone of circumferential fissuring partially separating it from the core [Figure 6(a)]. The mechanisms of "bark" separation from the core and formation of the larger cracks are likely linked since the cracks tended to turn at the interface between the "bark" and the core [Figure 6(b)]. The forces which produced the transverse (radial) cracks also acted as shear forces between the "bark" and the core.

An important finding was the detection of inflammatory cells partially migrated into and trapped within the fissures as shown in Figure 6(c). The shape of widened crevices and the depth of penetration indicated an active *in vivo* cellular migration. This phenomenon was observed at two separate sites.

FIGURE 6. Transmission electron microscopy. (a) Low power magnification of a cross-sectioned mesh fiber shows the degradation layer similarly to light microscopy, the insert shows an image composed of three high power fields to reconstruct the transition between the non-degraded core and the degradation "bark." Note the fine nanocracks/nanopores in the degraded material. (b) Outer part of the fiber with gradual transition between the non-degraded core and the degraded polypropylene at the surface. The lattice of nanocracks expands toward the surface (left to right). There are also two larger cracks which start perpendicular to the surface but then turn at the interface between the core and the degraded layer. (c) A part of inflammatory cell (labeled C in insert) is trapped in a fissure within the degraded polypropylene (PP). Higher magnification (insert) shows cellular membrane at the cell-polypropylene interface (left wall of the fissure) and cellular organelles in the cell (chains of rounded structures, likely ribosomes).

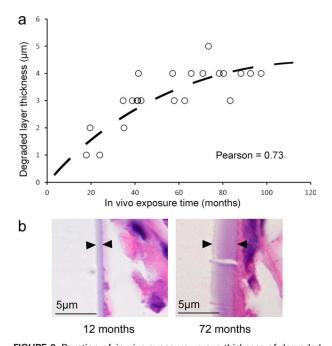
Out of all the specimens, 23 samples of explanted midure-thral slings formed the largest group of meshes from the same manufacturer, of identical mesh type and with reliable records of implantation and excision dates. The range of in vivo interval (between implantation to excision) in the group was 18-97 months (mean 53). There was a good correlation (Pearson = 0.73) between the thickness of the degradation layer and the duration of in vivo exposure indicating that the thickness of degraded material grows while the mesh is in the body [Figure 8(a,b)]. There was a trend for a more rapid initial growth with gradual plateau subsequently.

**FIGURE 8.** Duration of *in vivo* exposure versus thickness of degraded layer in a group of explants of the same manufacturer and the same mesh design. (a) Thickness of the degradation "bark" increased over the years *in vivo* (Pearson correlation = 0.73). Note the trend of plateauing after 5–6 years. There was no correlation of the thickness with the duration of specimen storage in formalin (not shown, Pearson = -0.06). (b) Comparison of the "bark" in meshes explanted after 12 and 72 months in the body, H&E,  $\times$ 100 objective with oil immersion, images cropped to the same magnification factor. [Color figure can be viewed in the online issue, which is available at wileyonlinelibrary.com.]
